Manhole Inspection Summary

Manhole # S29YY_034MH

Location Address: **3350 34TH ST**

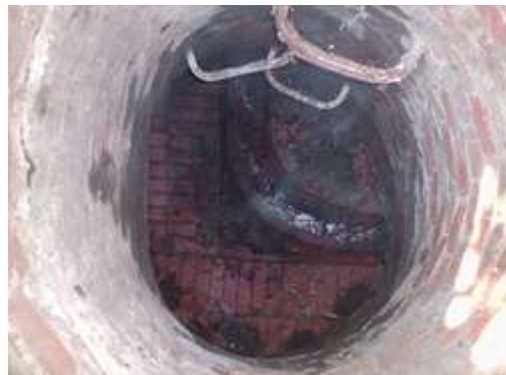
Top View

Corroded steps. Bench debris.

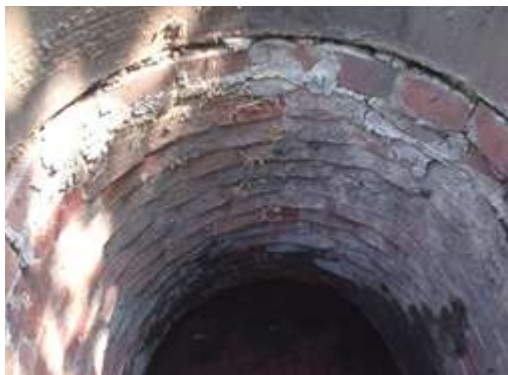
Defect

Frame leaks. Adjustment deterioration and infiltration. Corbel and Barrel infiltration - other side.

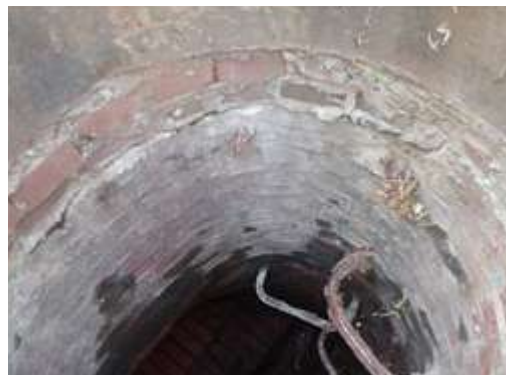
Defect

Frame leaks. Adjustment deterioration and infiltration. Corbel and Barrel infiltration. Corroded and missing steps.

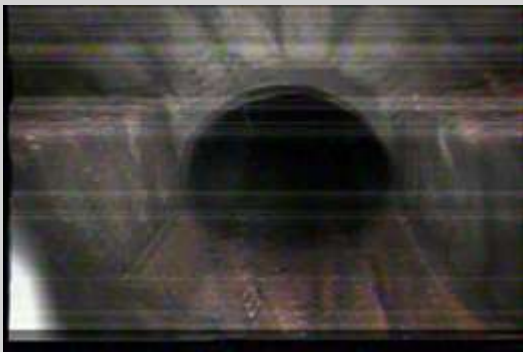
8 in. Circular Gravity Sewer Pipe Out @ 12 O'Clock

Infiltration: **Evidence** Pipe Seal Cond: **Unknown**
